Partnerships in Wetland Management

Working together to manage
wetlands today and into the
future

Duck Creek and Mingo

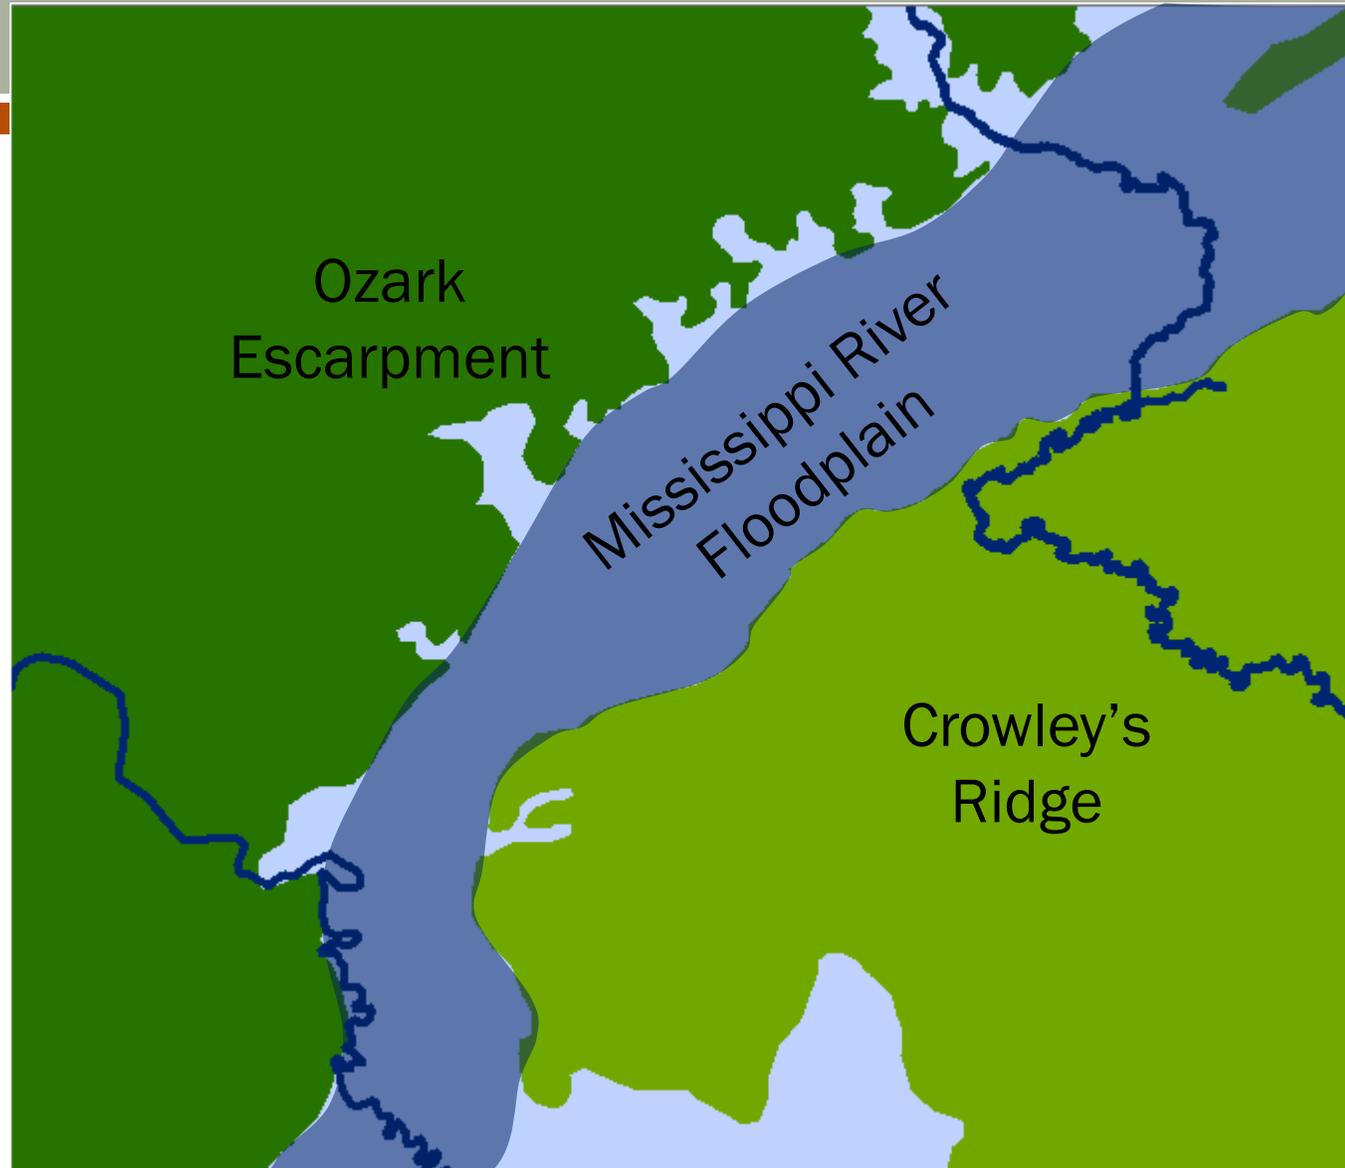
The Mingo Basin

Mississippi
Alluvial Valley

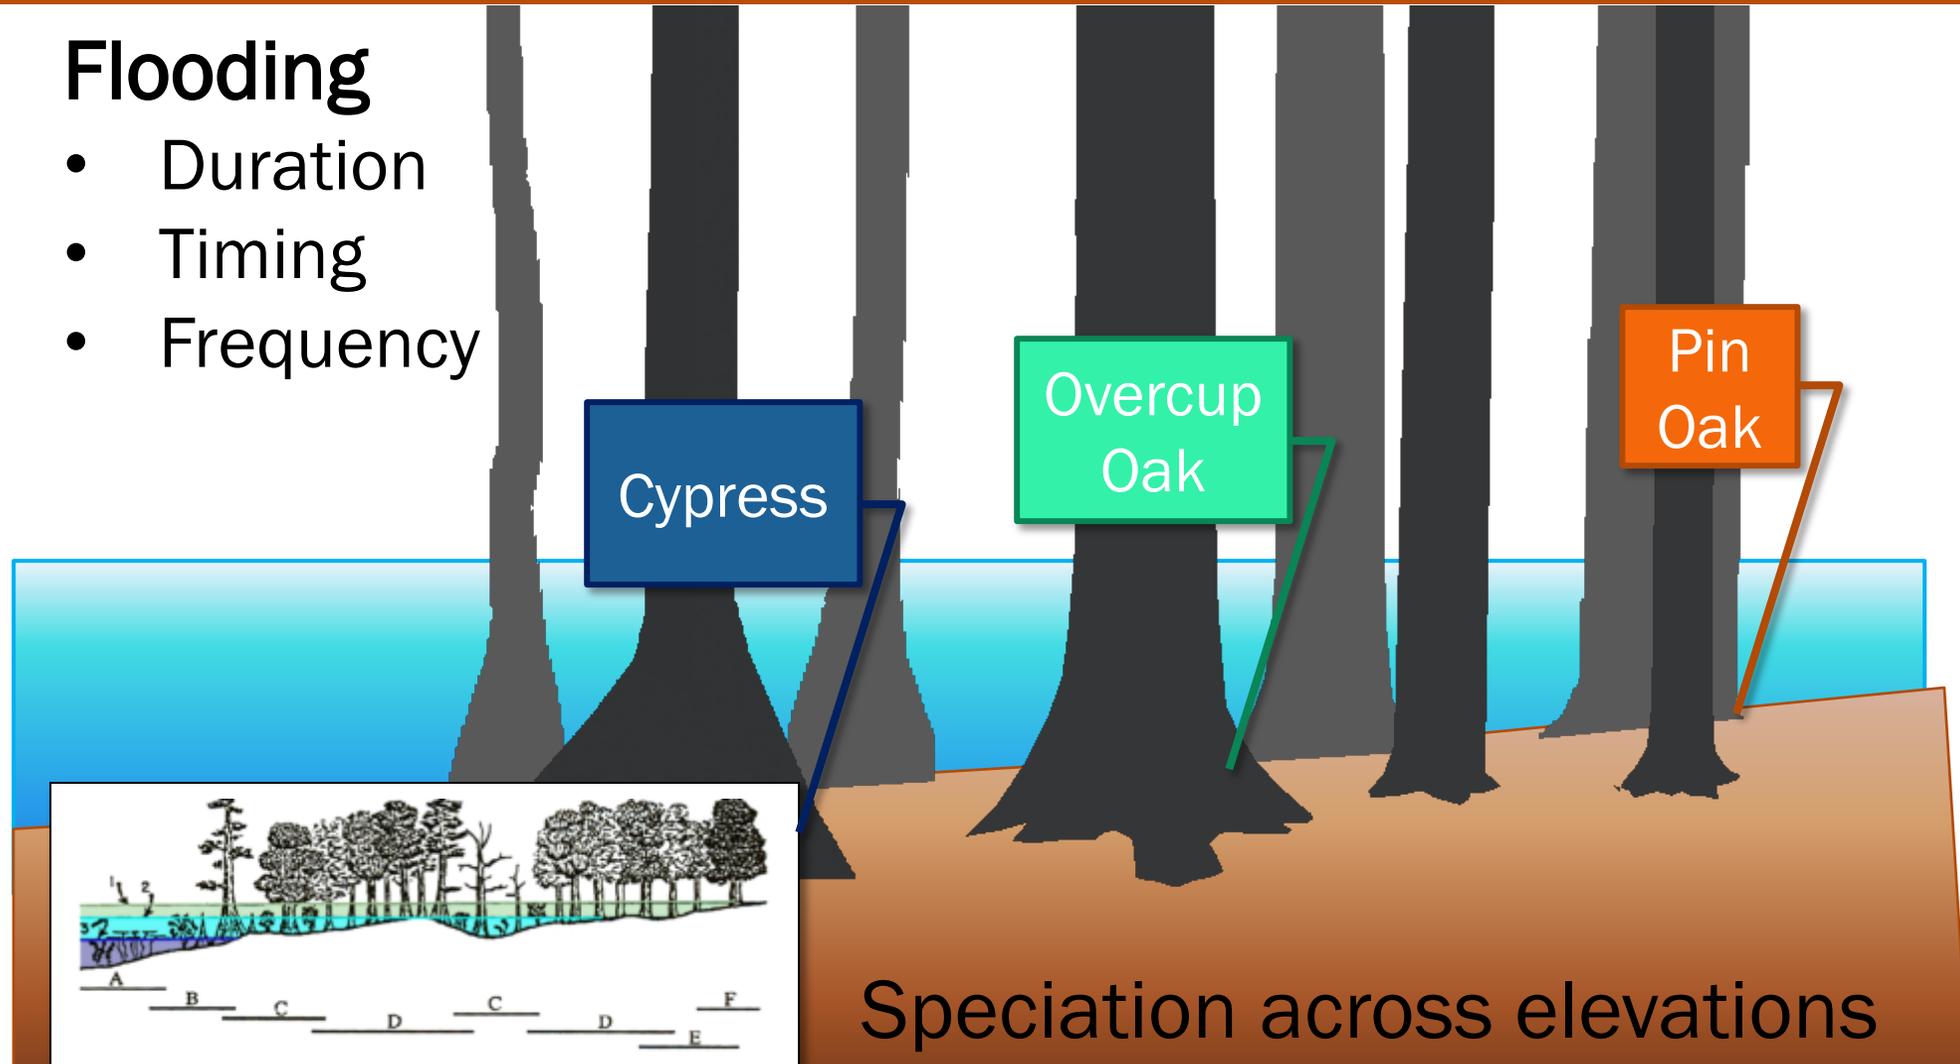
Bottomland Hardwood Communities

Flooding

- Duration
- Timing
- Frequency

Speciation across elevations

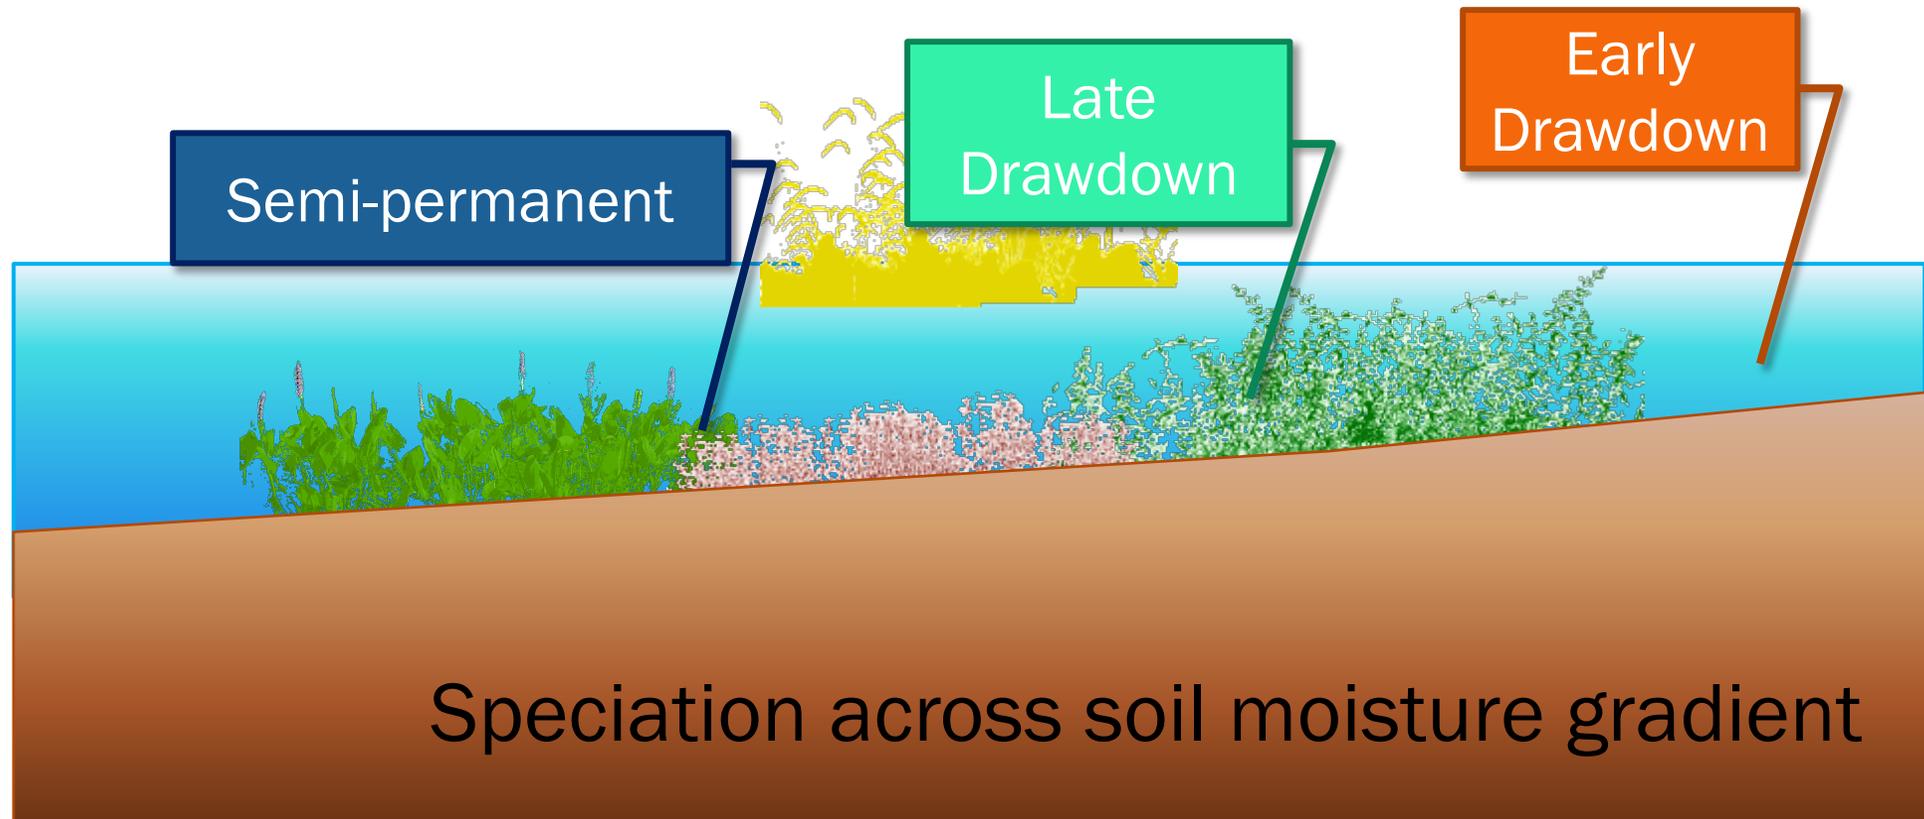
Herbaceous Wetland Communities

Flooding

- Duration
- Timing
- Soil Type
- Water Depth

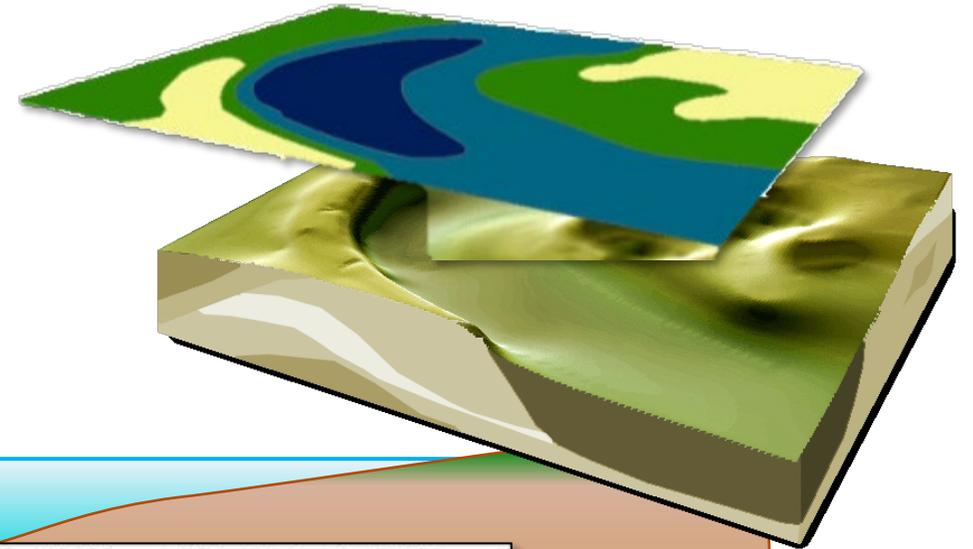
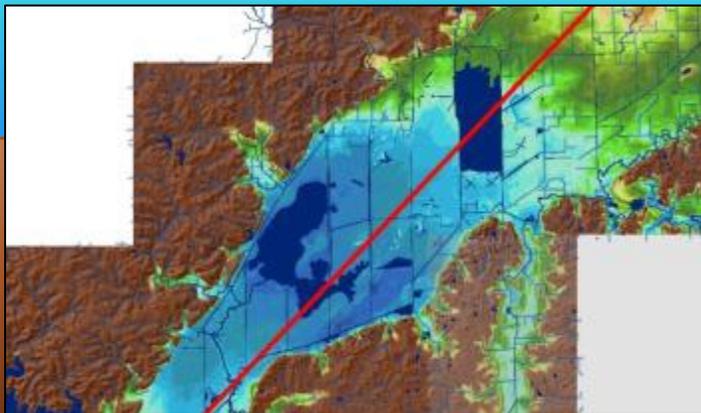
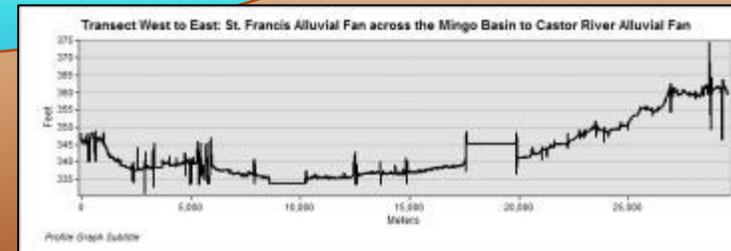
Managing water

Topography

- Underlying factor for management
- Understanding is critical
- Digital Elevation Models
 - Lidar, RTK, Conventional Survey

Extent of Suitable Habitat

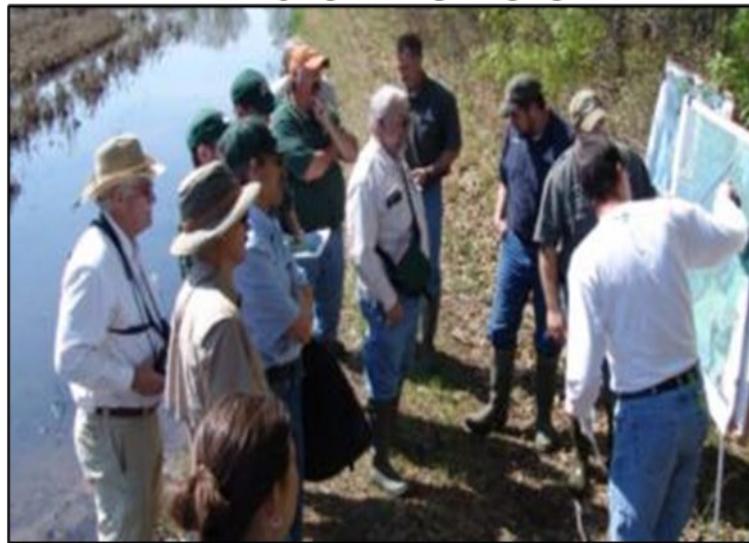
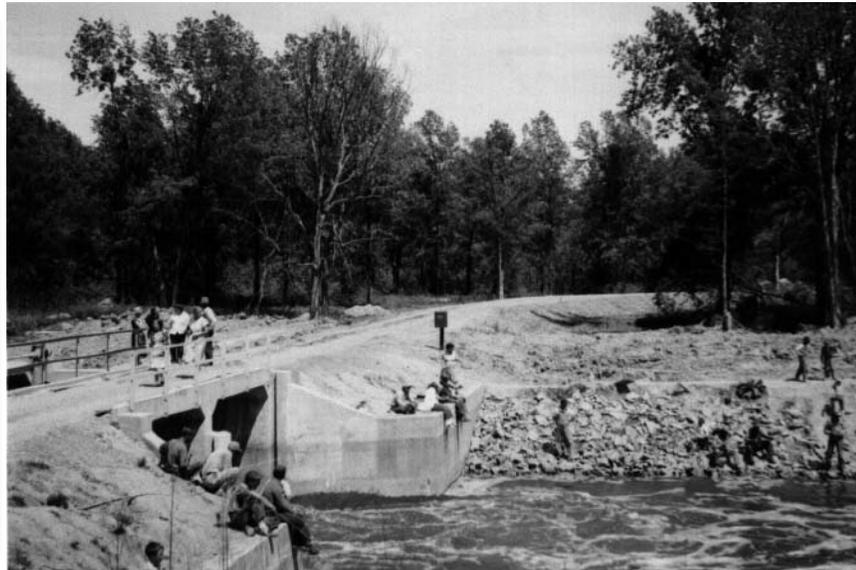
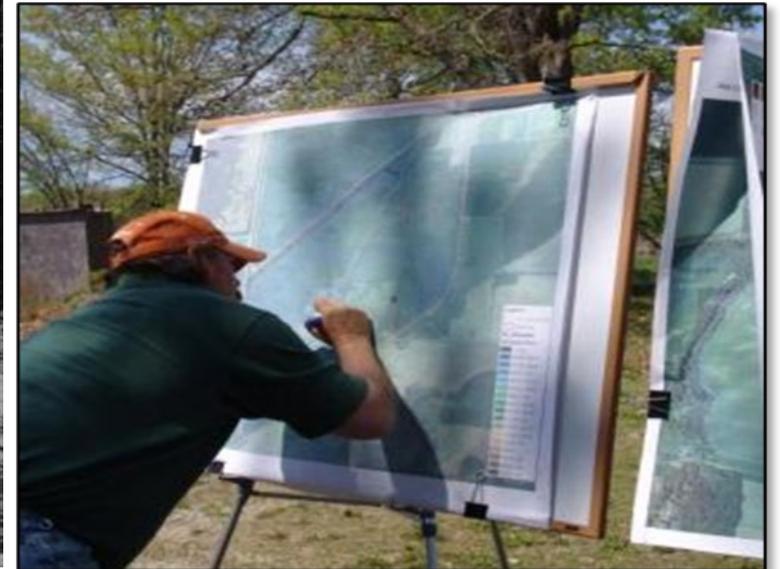
NAWCA – Taking Turns

- NAWCA I - Restoration of Units A and B at Duck Creek
- NAWCA II - Removal and installation of a new spillway at Mingo NWR
- NAWCA III – Restoring forest resources in Pools 2 and 3 at Duck Creek

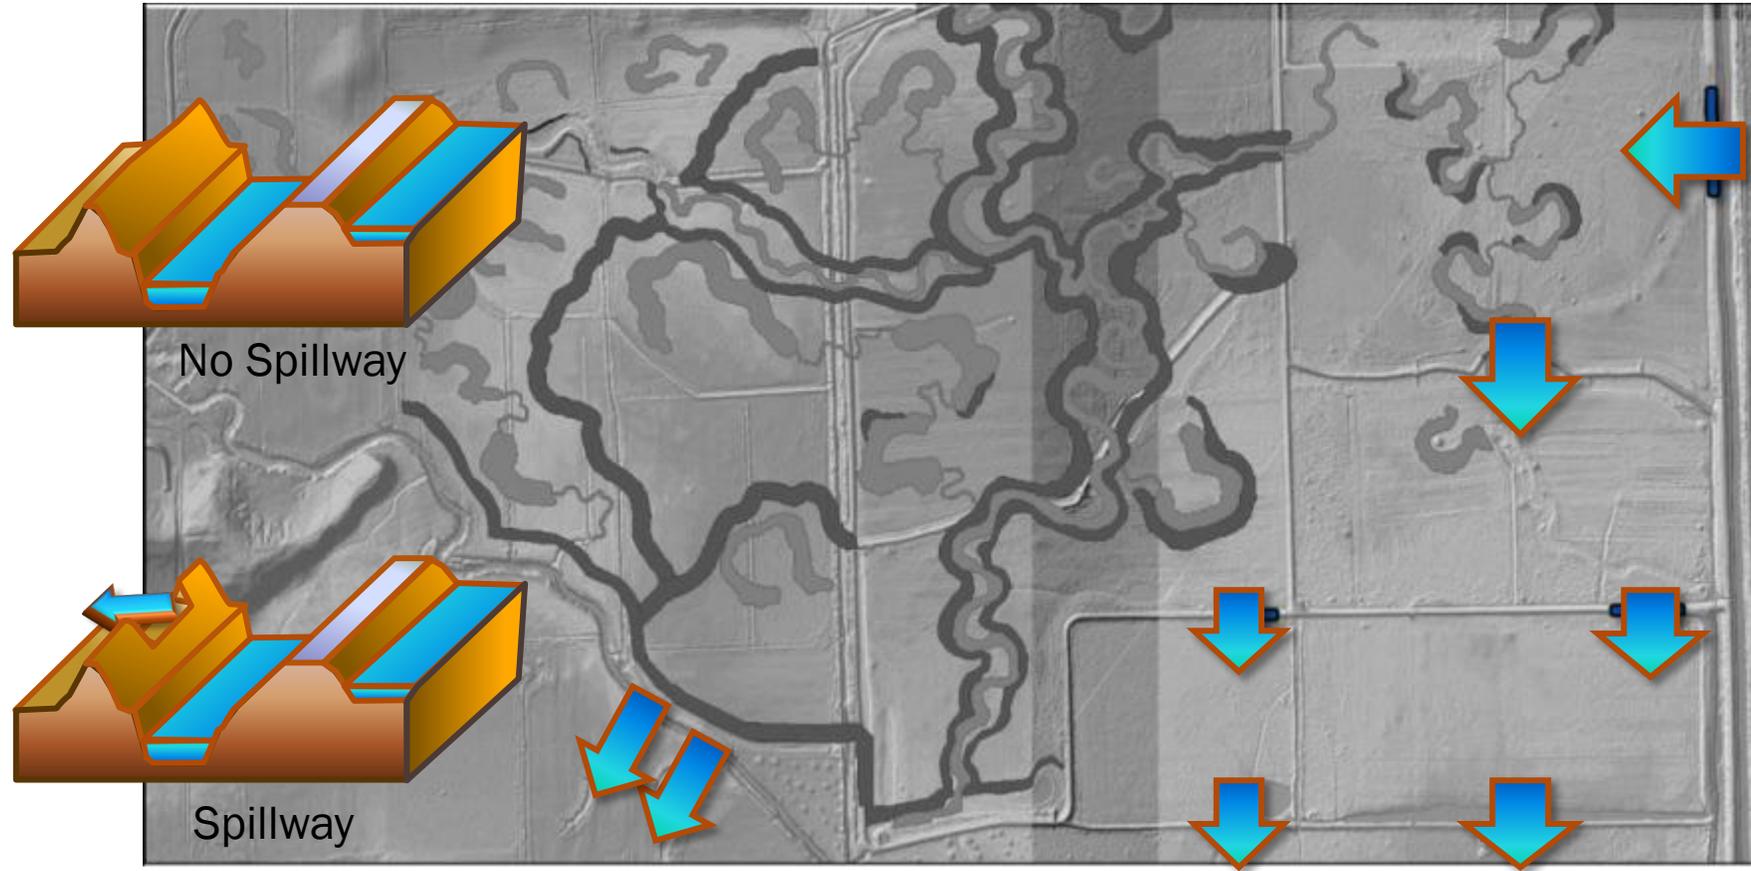
NAWCA I -Restoring Natural Water Flow Patterns

Notching Levees for Flood Relief: Cut down to full pool elev. Allow flood waters to spreadout

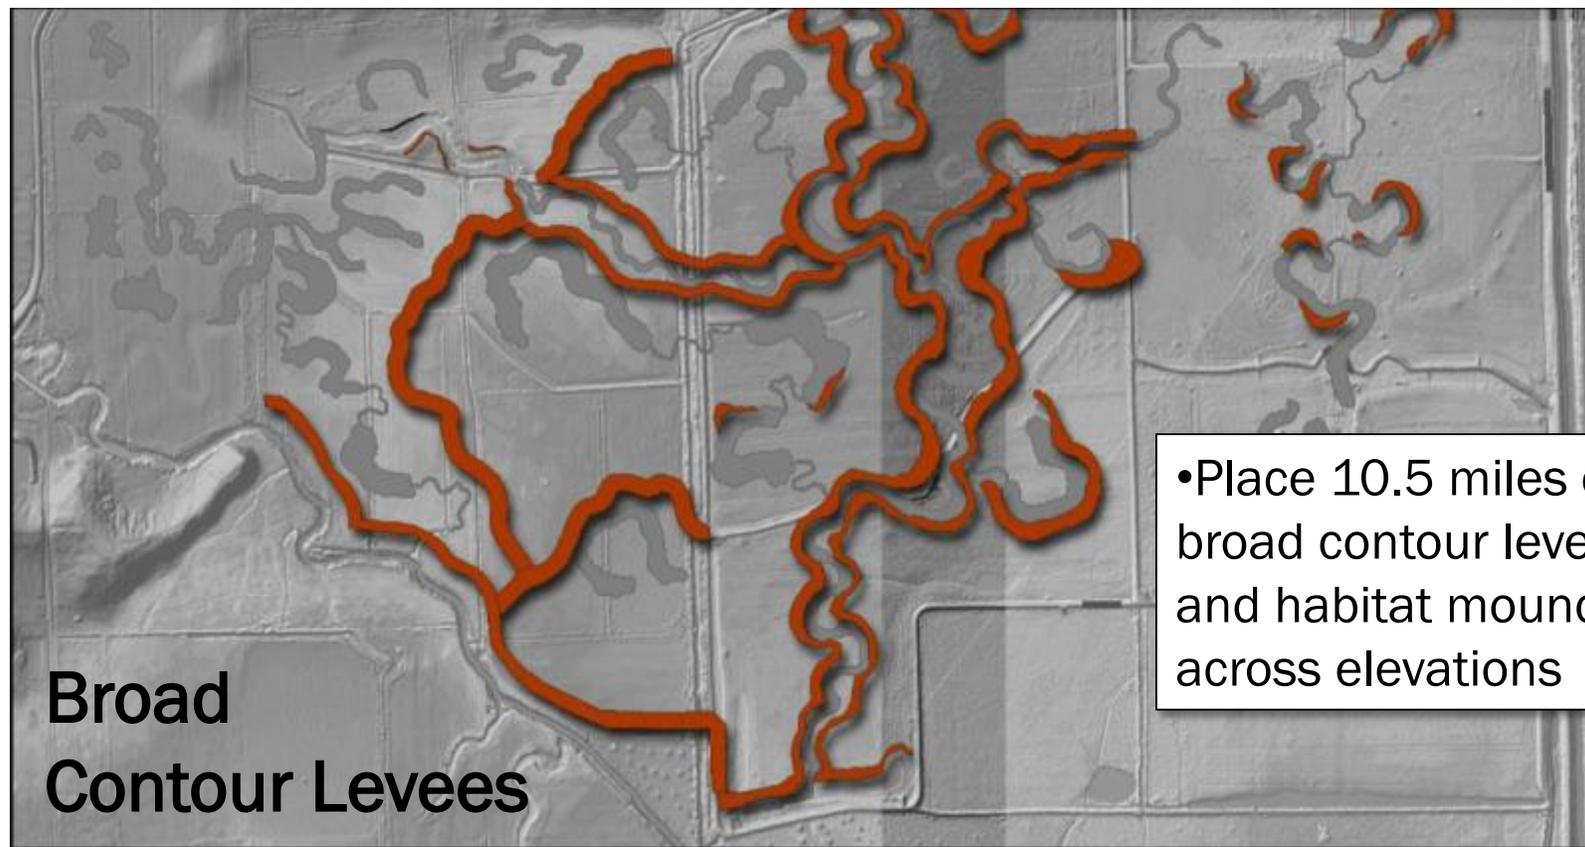
NAWCA I - Mimicking Natural Water Regimes

Contour levees: 10:1 side slopes, located along 2-2.5 contours, <6 inch freeboard

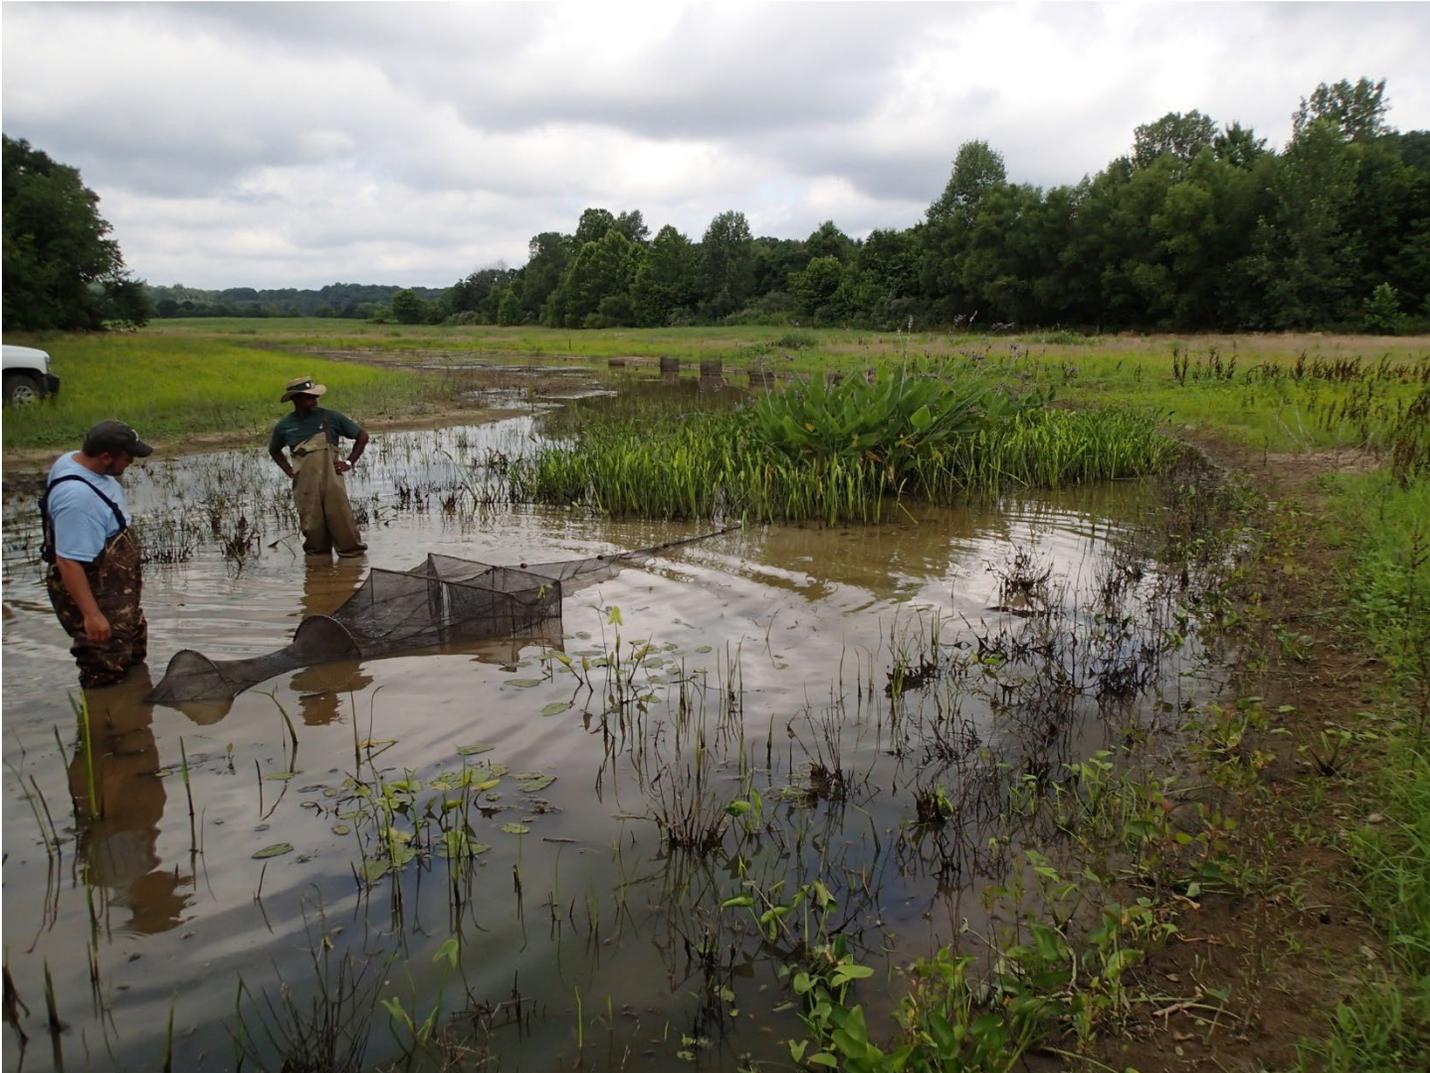
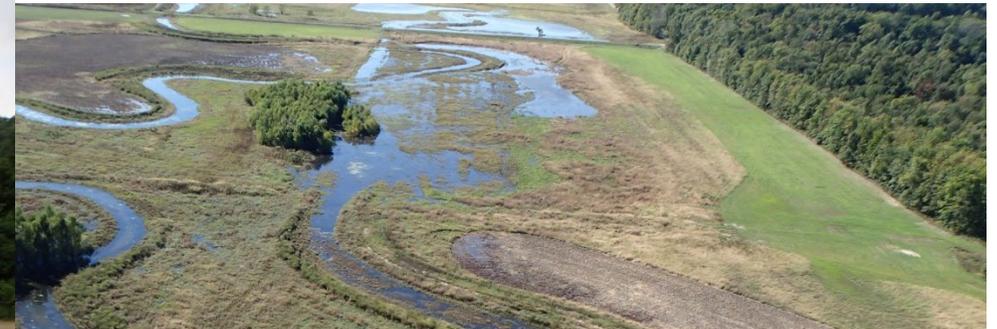
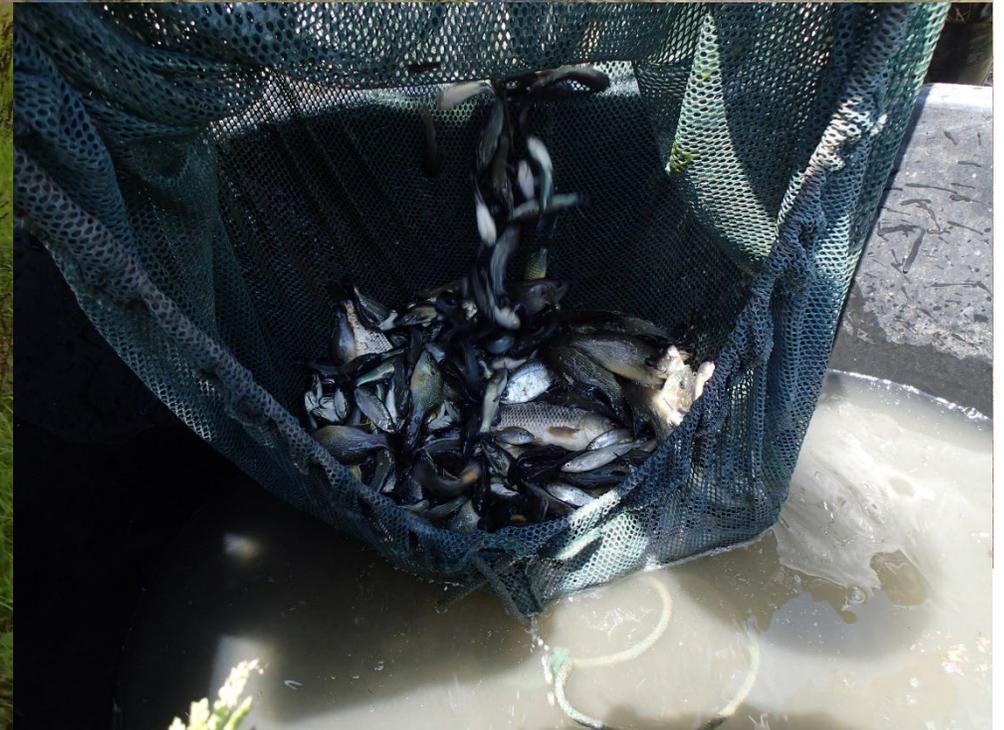
NAWCA I - Mimicking Natural Water Regimes

Stream Restoration and Creative Scours:

Allow for independent water control, slow down water, spread it out, increase habitat diversity

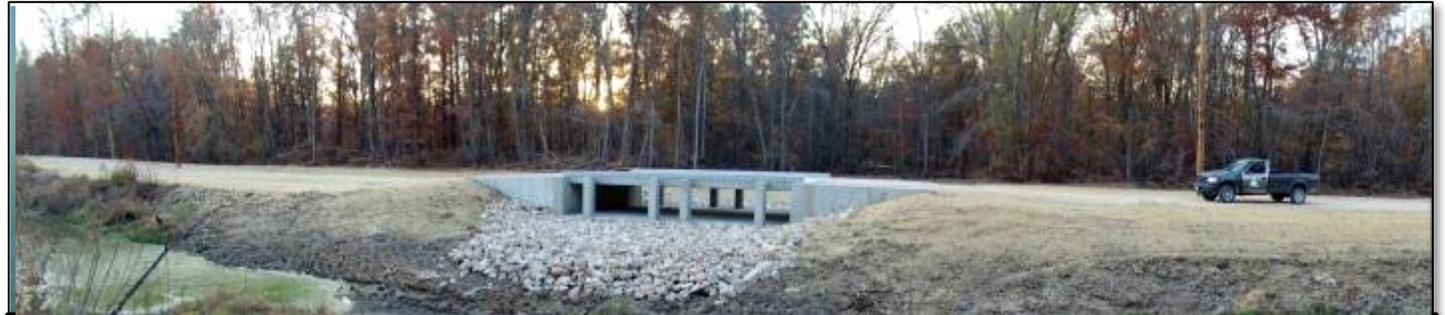
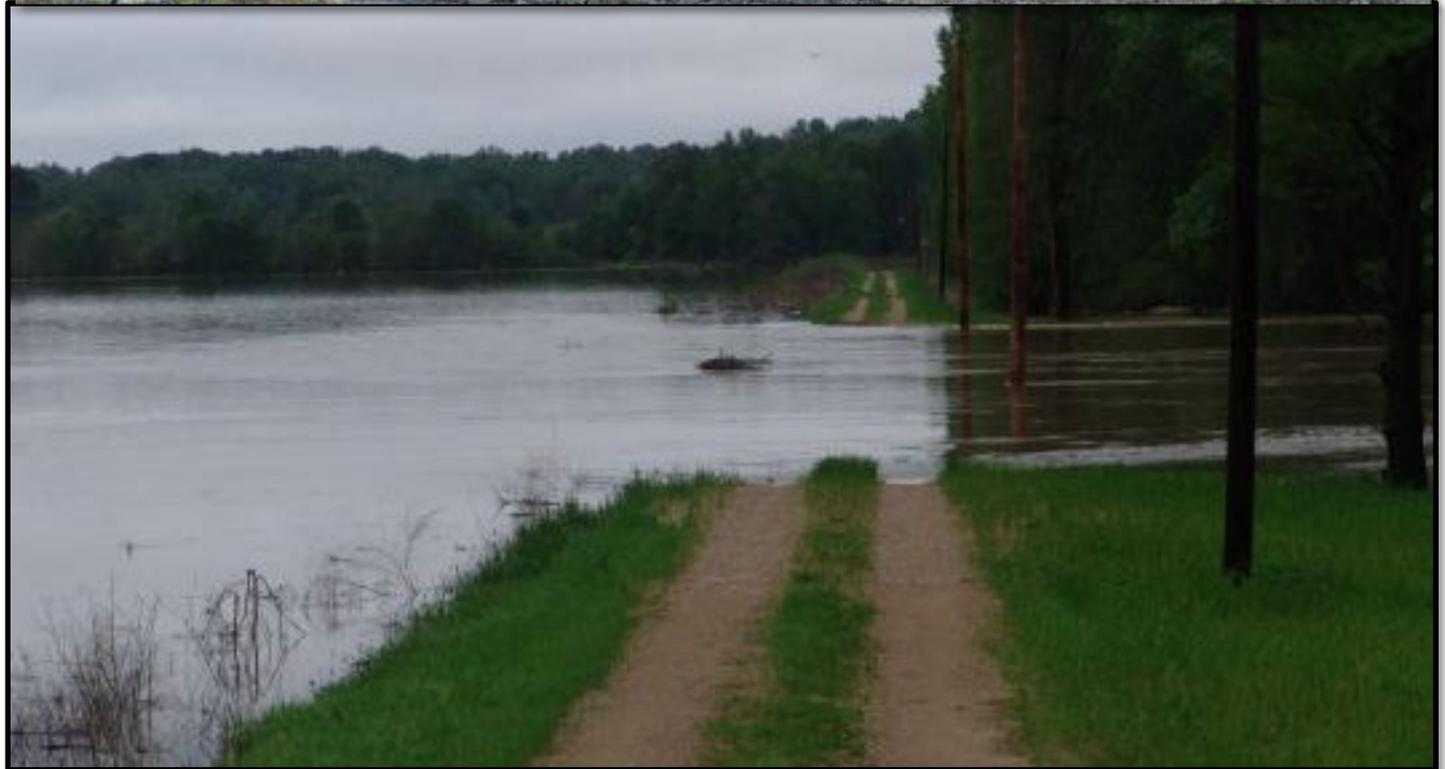
NAWCA III — Pools 2 & 3 Infrastructure

- Managing Forest Resources at the landscape level
- Broad structures keep water moving
- Water flow is critical to forest health

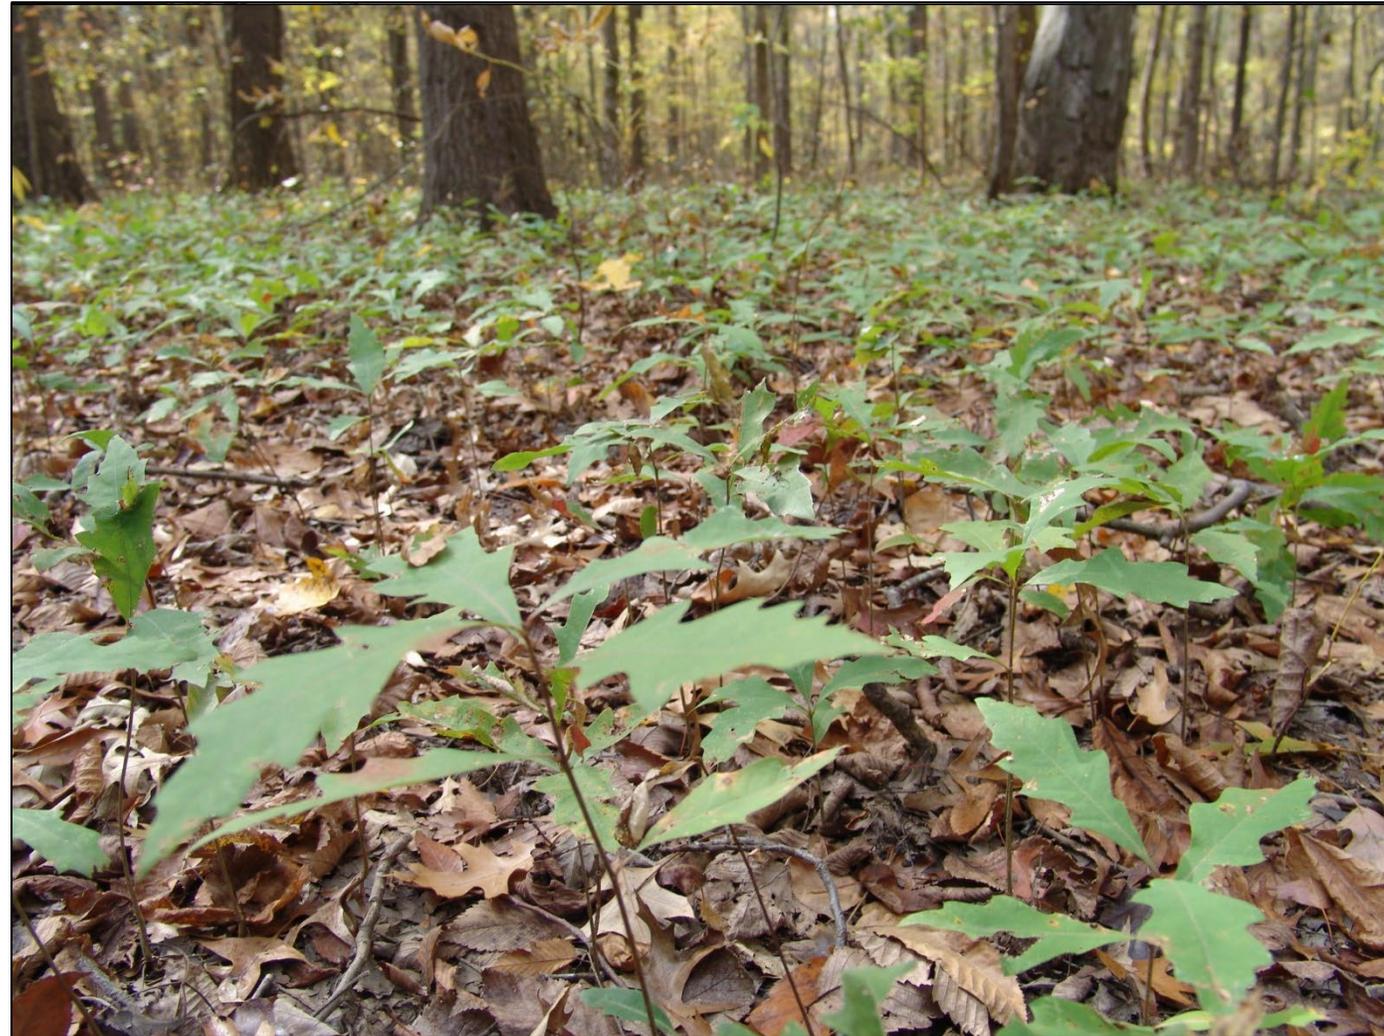
NAWCA III – Pools 2 & 3 Infrastructure Removal

- Managing Forest Resources at a micro level
- ID'd areas of oak mortality as places water was trapped
- Lidar helped prioritize which spoil piles were causing problems
- Water flow is critical to forest health

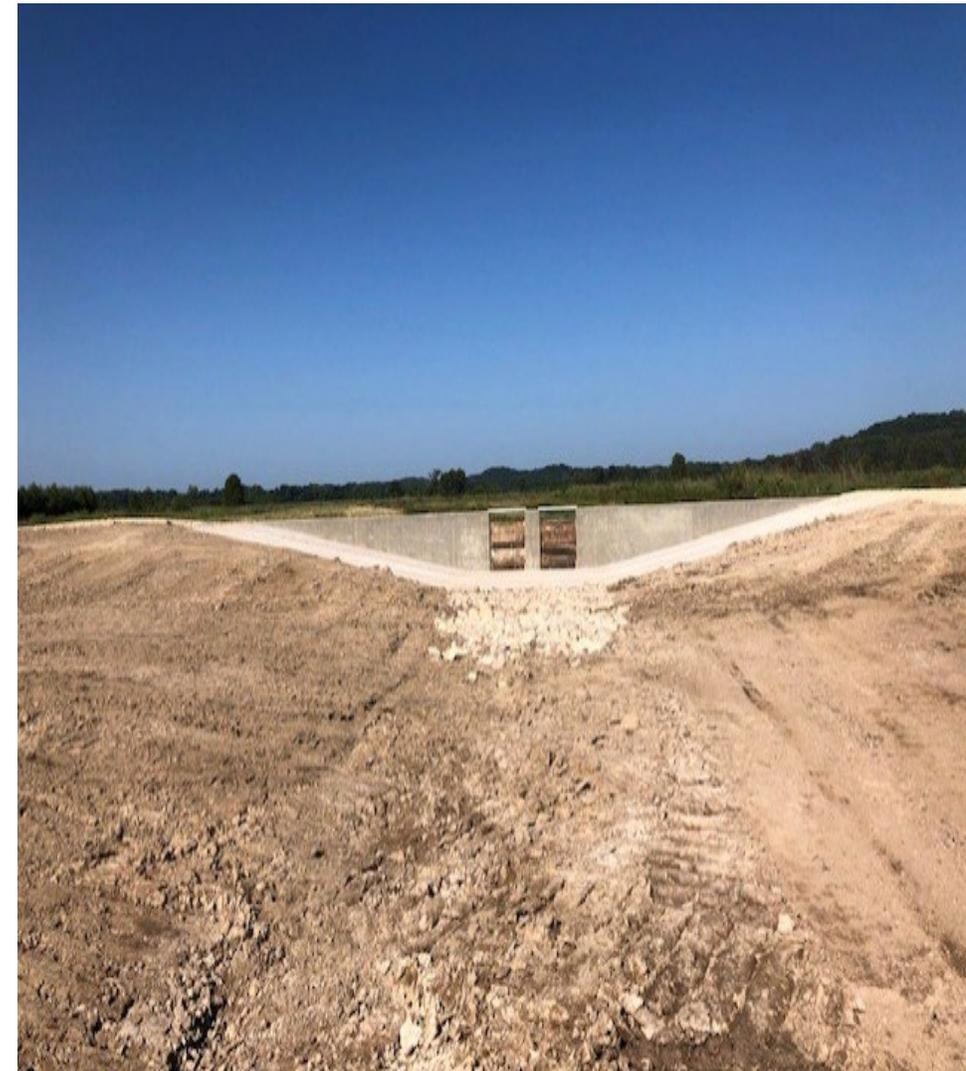
Projects

1. Low water crossings
2. Levee Breaches
3. Water Control Structure Replacement
4. Ditch 10 Plug Removal
5. New Irrigation Well

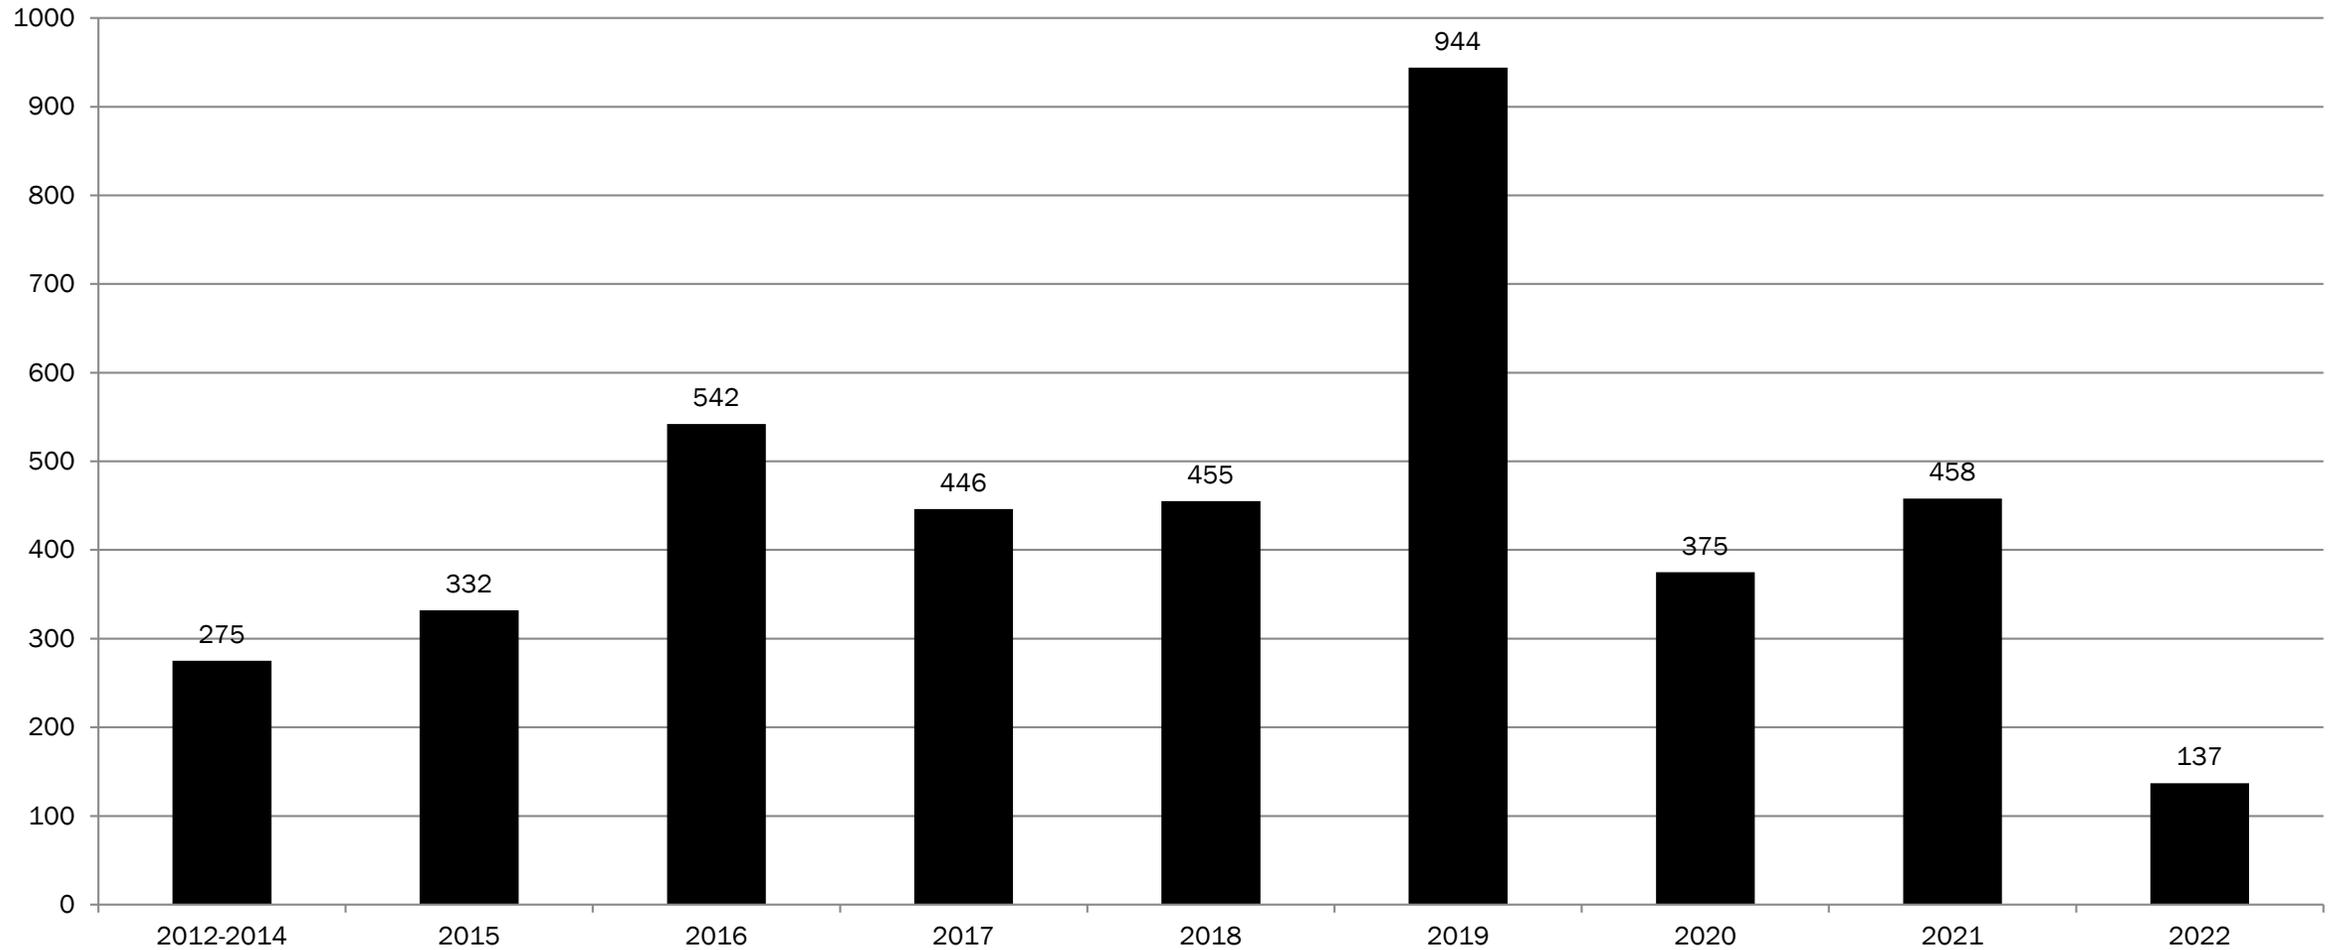
Feral Hogs Killed by Year on Mingo NWR since 2012

What success looks like
